DEPARTMENT OF TRANSPORTATION

Quality Assurance and Source Inspection

Contract #: 04-0120F4Cty: SF/ALA Rte: 80 PM: 13.2/13.9File #: 69.28**WELDING INSPECTION REPORT****Resident Engineer:**Pursell, Gary**Address:** 333 Burma Road**City:** Oakland, CA 94607**Report No:** WIR-014063**Date Inspected:** 01-May-2010**Project Name:** SAS Superstructure**OSM Arrival Time:** 700**Prime Contractor:** American Bridge/Fluor Enterprises, a JV**OSM Departure Time:** 1900**Contractor:** Zhenhua Port Machinery Company, Ltd (ZPMC), Changxing Island **Location:** Shanghai, China**CWI Name:** Mr.Tian Lei /Mr. Li Jia**CWI Present:** Yes No**Inspected CWI report:** Yes No N/A**Rod Oven in Use:** Yes No N/A**Electrode to specification:** Yes No N/A**Weld Procedures Followed:** Yes No N/A**Qualified Welders:** Yes No N/A**Verified Joint Fit-up:** Yes No N/A**Approved Drawings:** Yes No N/A**Approved WPS:** Yes No N/A**Delayed / Cancelled:** Yes No N/A**Bridge No:** 34-0006**Component:** Orthotropic Box Girder(OBG)**Summary of Items Observed:**

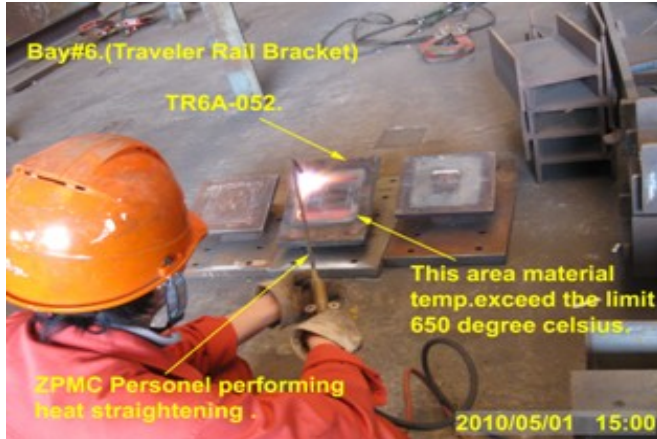
During the Quality Assurance random in-process observations of the fabrication of OBG Traveler Rail (TR) brackets, this Caltrans Quality Assurance Inspector (QA) observed ZPMC personnel flame straightening traveler rail base plate. The material was heated to a bright red condition. Per ZPMC Heat Straightening Report identified as HSR1 (B)-8405, the maximum temperature is 650 Degree Celsius. AWS D1.5 2002 defines the color of material heated to 650oC as a “dull red color”. A temperature indicating crayon, digital temperature measurement gauge, or other similar means of monitoring the temperature was not utilized by ZPMC QC and the actual maximum attained temperature was not measured. The Traveler rail is identified as TR6A-052. The base material thickness measured 30mm. A video of this worker heating this TR bracket has been put on the Caltrans server for review. It can be found under Team OBG//video archives//TR6A-052_B299_05-01-10_video_heat straightening. This QA Inspector generated an incident report on this date, for further information see the incident report and attached photograph.
